Legionella Outbreak Associated with St. Columbkille Parish

*Parma, Ohio
July, 2018*

2019 Midwest Conference
March 26, 2019

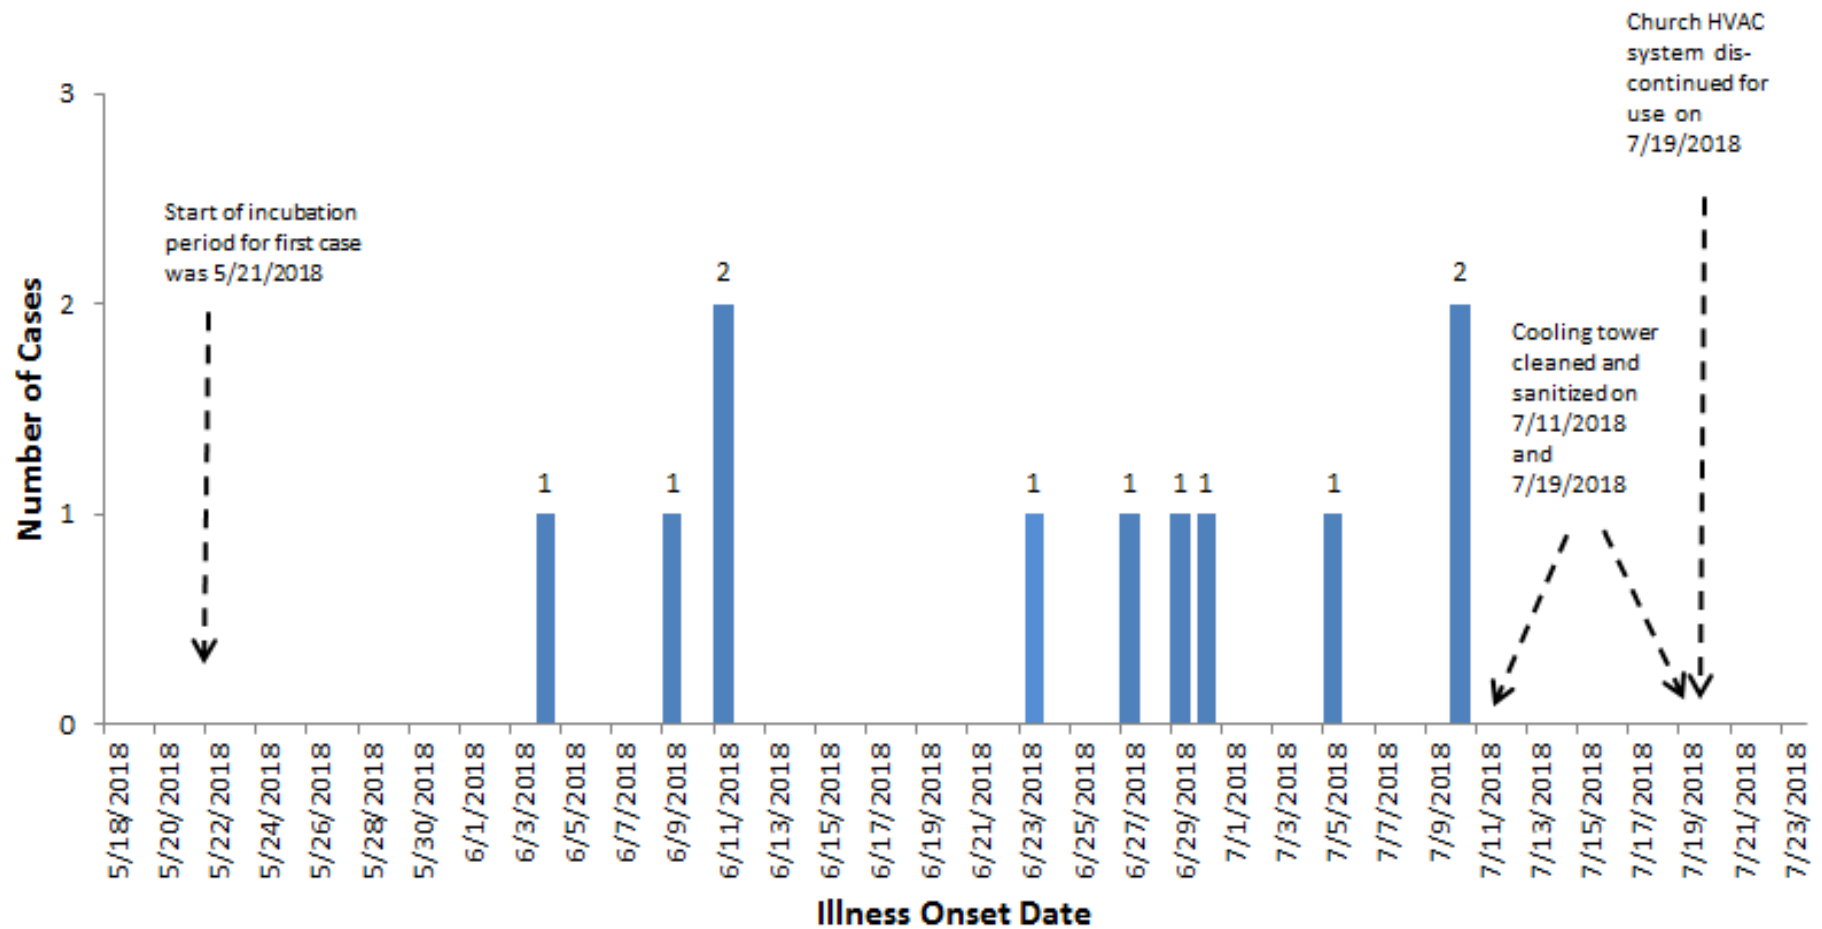
Epi Curve by Onset Date

- 11 cases were associated with the outbreak
- Church attendance was indicated between 5/27 and 7/9
- 73% were female (8 female; 3 male)
- Median age was 78 (range = 74 to 93 years)
- 7 cases lived in Parma, 2 in Seven Hills, 1 in Broadview Heights and 1 in Independence
- There was 1 death
- All were diagnosed by Legionella urine Ag testing by area hospitals

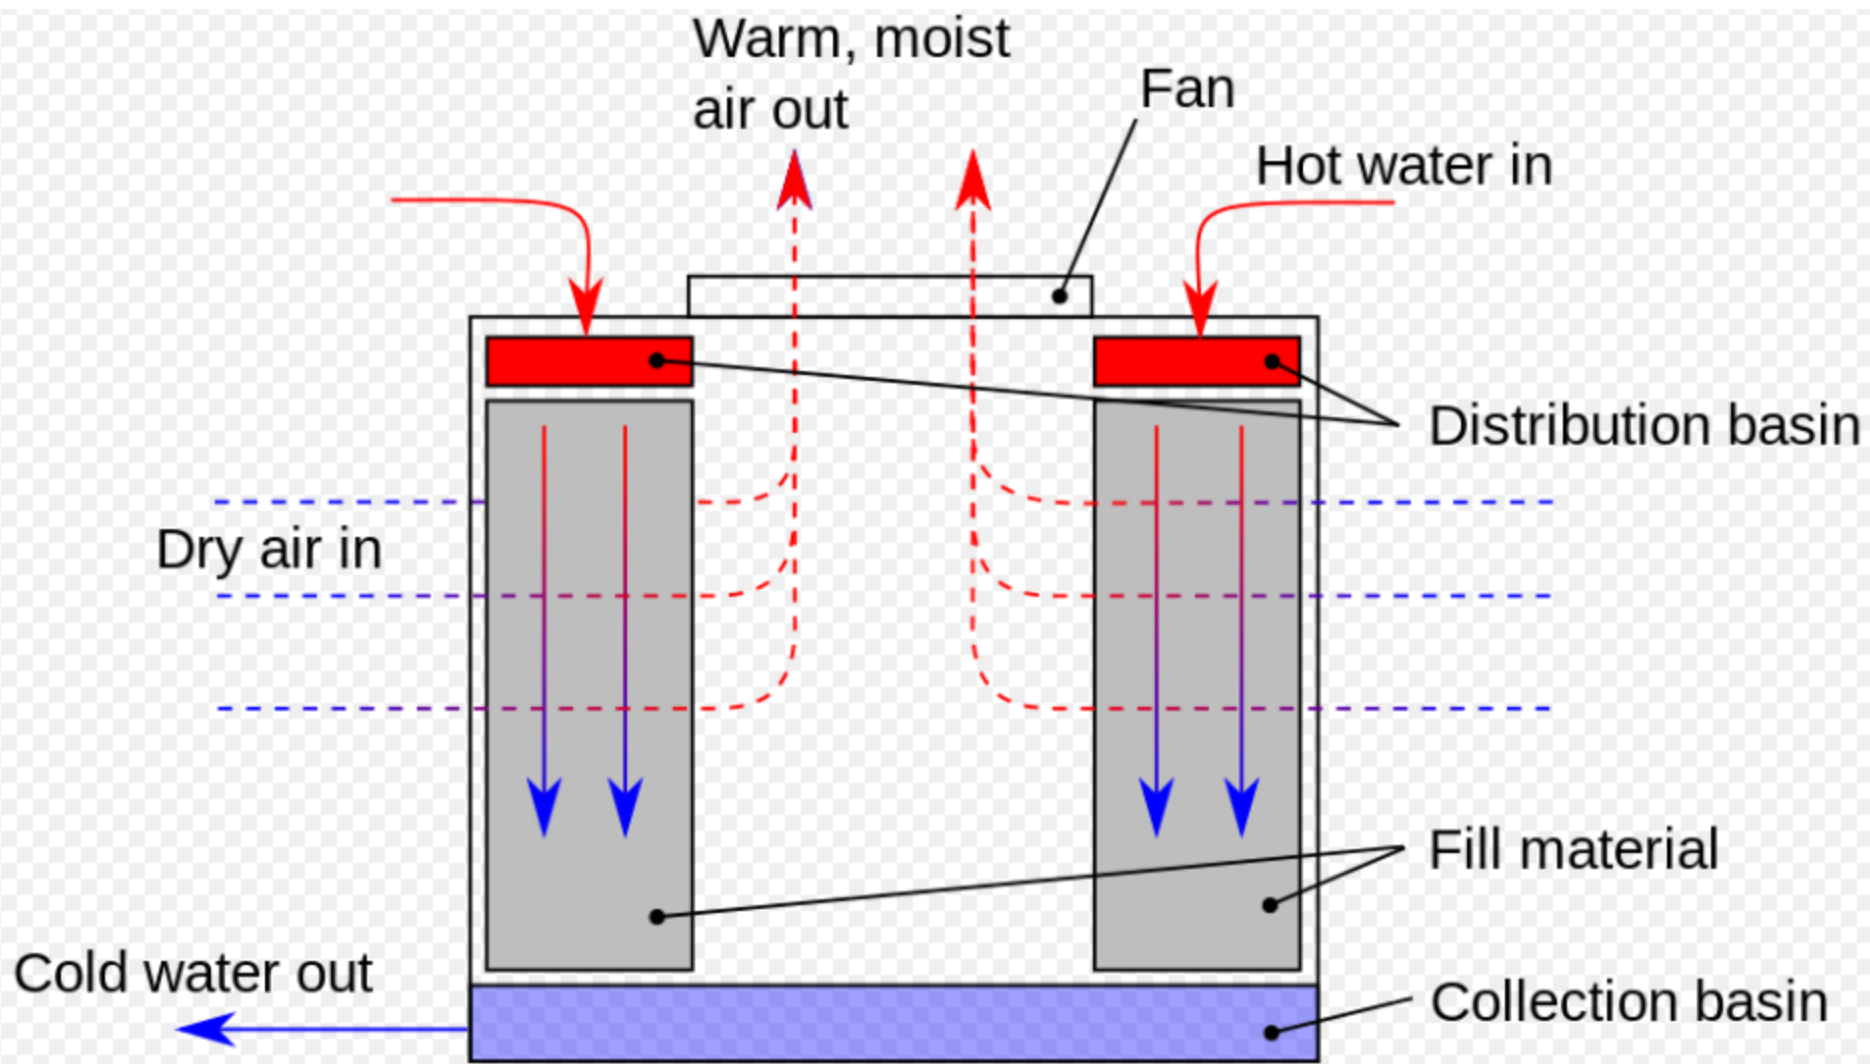
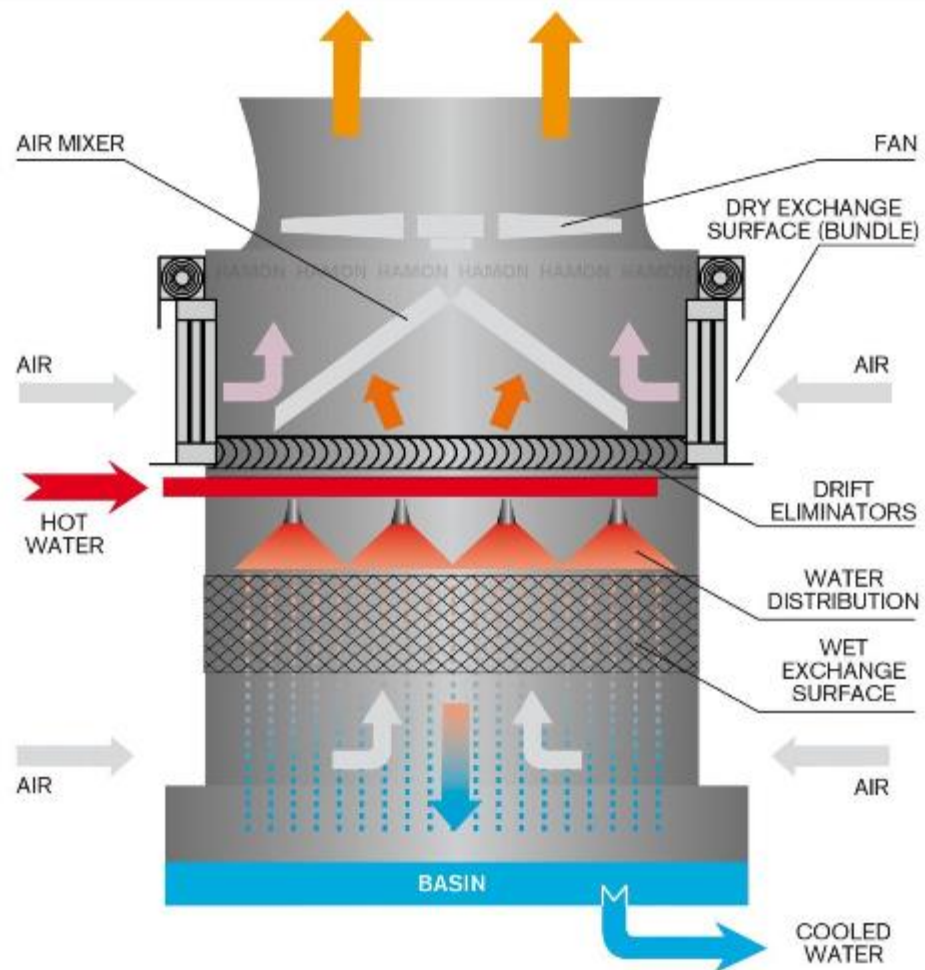
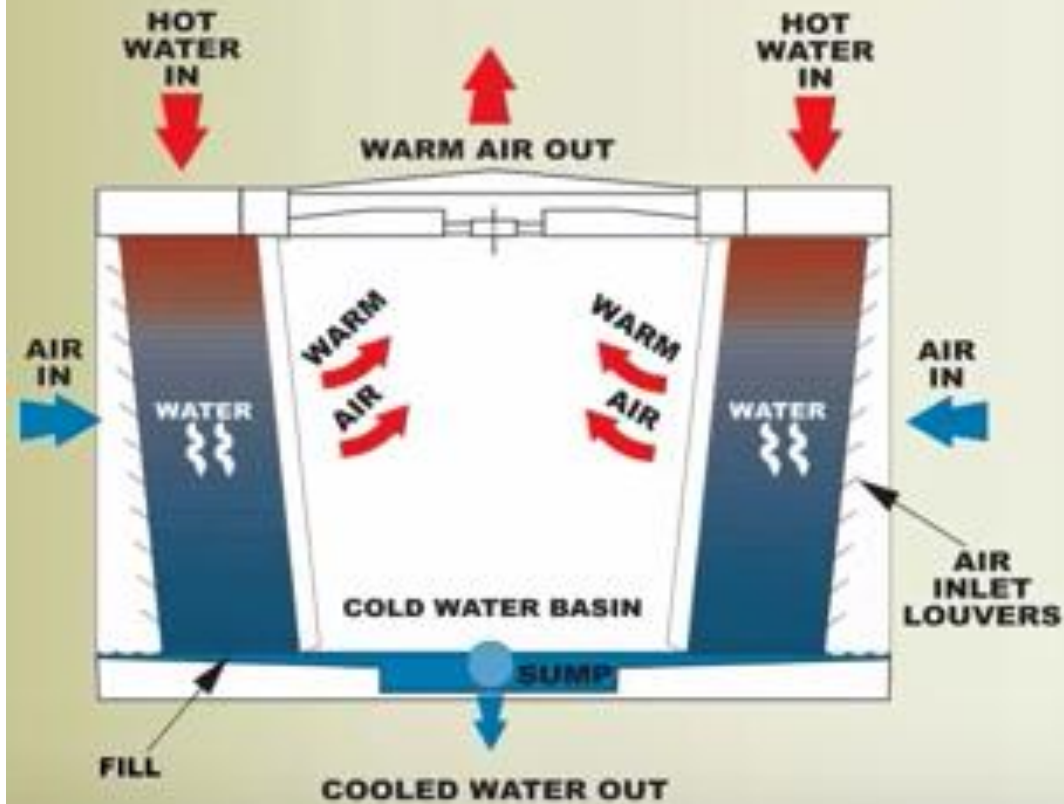
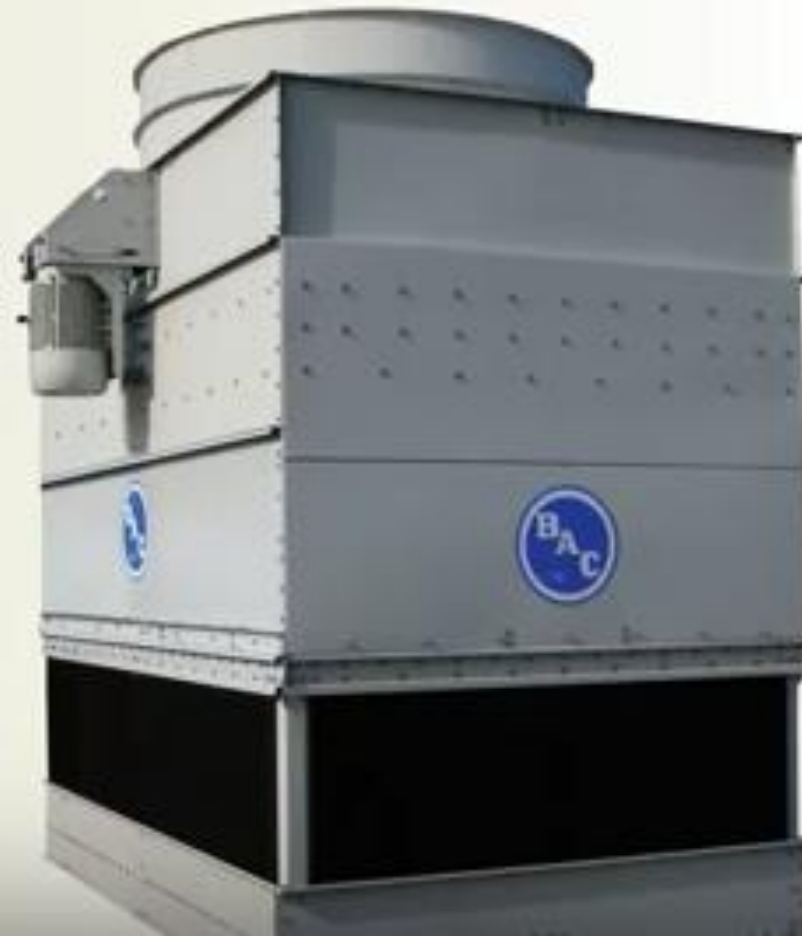
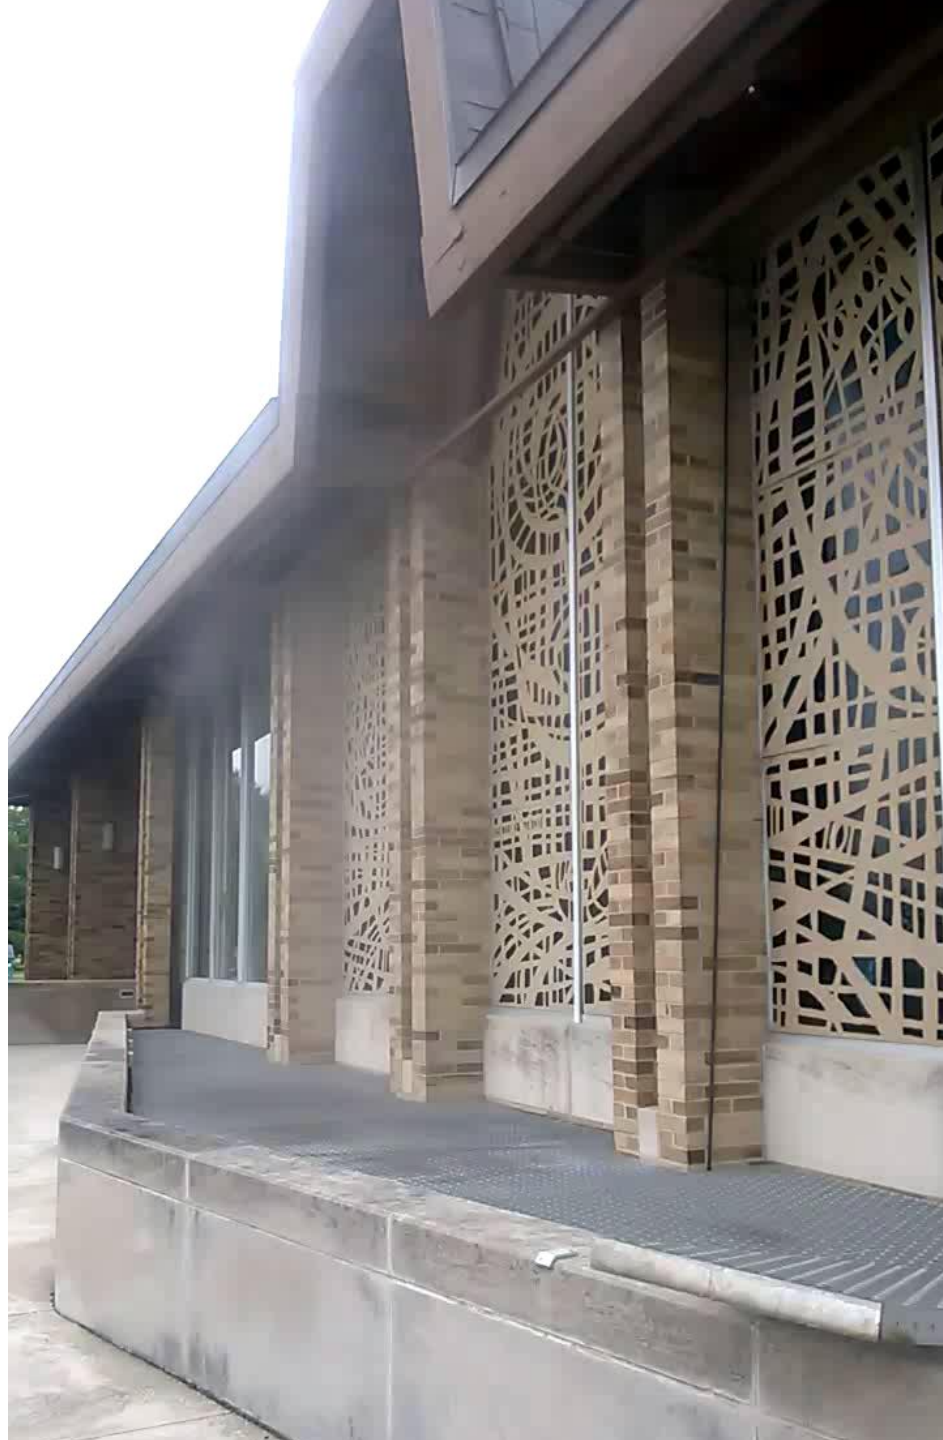
THE COOLING TOWER

- Design, location, maintenance.
- Observe cooling tower operation under “normal” operating conditions (manual/intermittent).
- Evaluate whether “drift” from tower could present an exposure risk.
- Obtain maintenance, service records, and water chemistry reports.

- The design, operation, and location of the current cooling system at St. Columbkille church provided a significant risk and a very likely mode of transmission and pathway for exposure for the Legionnaires' disease cases

- Based on its present location, design, operation and maintenance, the cooling tower should not be operated
- Develop and follow ASHRAE 288-compliant Legionella water management plan for all of the water sources in the parish facilities
- Consult with the qualified Heating, Ventilation and Air conditioning engineer for guidance in addressing the issues and risks related to the location, design, operation and maintenance of the cooling tower
- Develop an ongoing communication plan regarding water management
